# Bonded Concrete Overlay Performance In Illinois

**FINAL REPORT**  
**PHYSICAL RESEARCH REPORT NO. 143**  
**JUNE 2002**

**Illinois Department of Transportation**

BONDED CONCRETE OVERLAY PERFORMANCE  
IN ILLINOIS

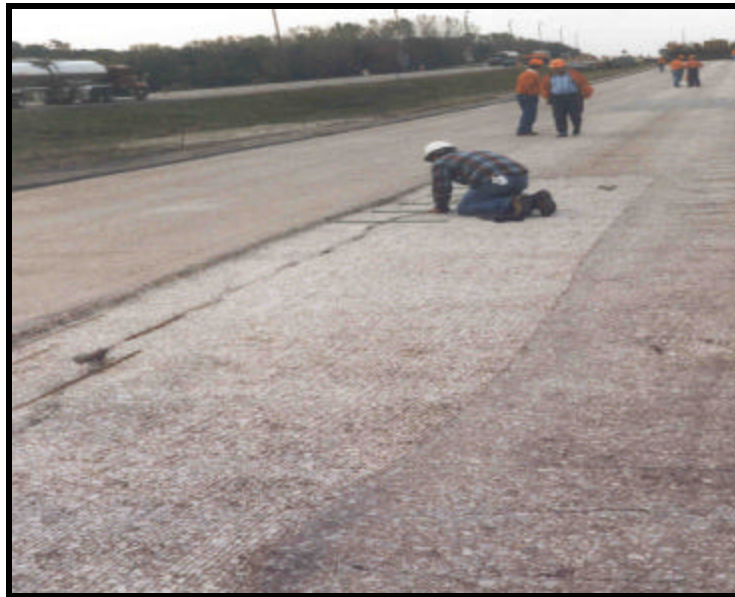
Figure 4  
Partial-Depth Patch Reinforcement

One partial-depth patch was required in the eastbound direction and eight were required in the westbound direction. These patches were placed over severe longitudinal cracks. The existing surface was milled down to a depth of 2.5 inches by 36 inches wide. The crack was reinforced with #5 tie bars placed at 90 degree angles to the crack on 30-inch centers. These concrete patches were placed monolithically with the concrete overlay. Figure 4 illustrates the placement of the reinforcement bars within a partial depth patch area. The combined area of these patches was 0.28 percent of the total project roadway area.
